National Transportation Safety Board

Pipeline Accident Brief

Natural Gas Explosion at Educational Facility

Minneapolis, Minnesota

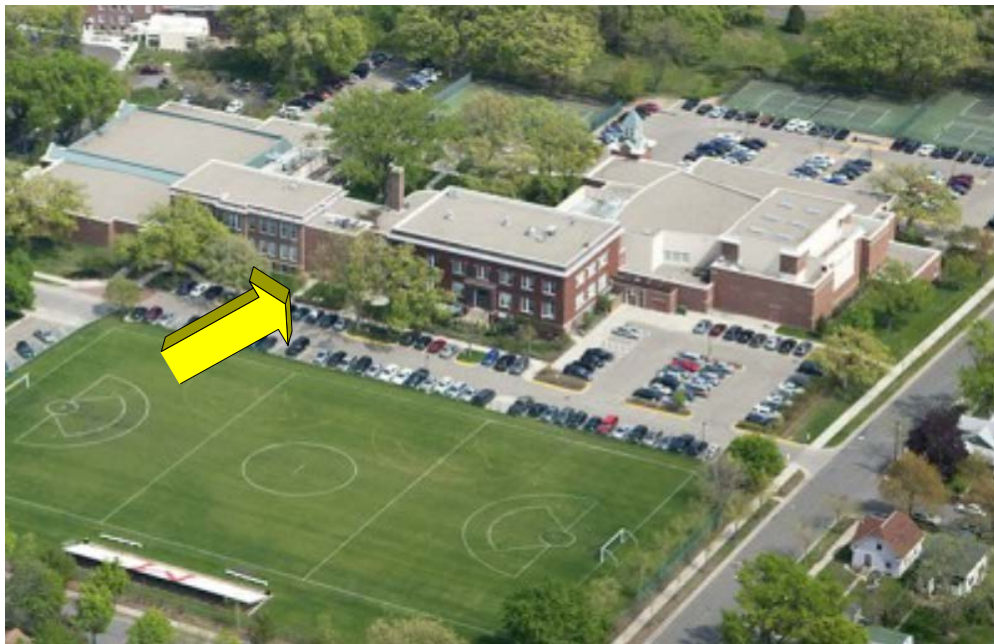
Figure 1. Photograph of north campus area at Minnehaha Academy prior to explosion. (Source: minnehahaacademy.net.)

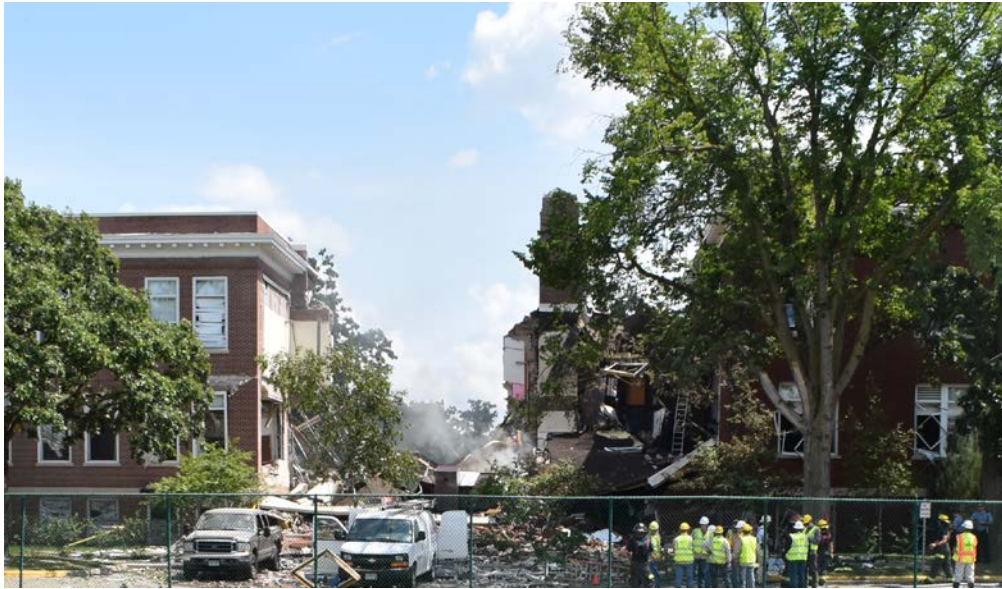
Figure 1. Photo of accident site taken after building explosion. (Source: Minneapolis Fire Department.)

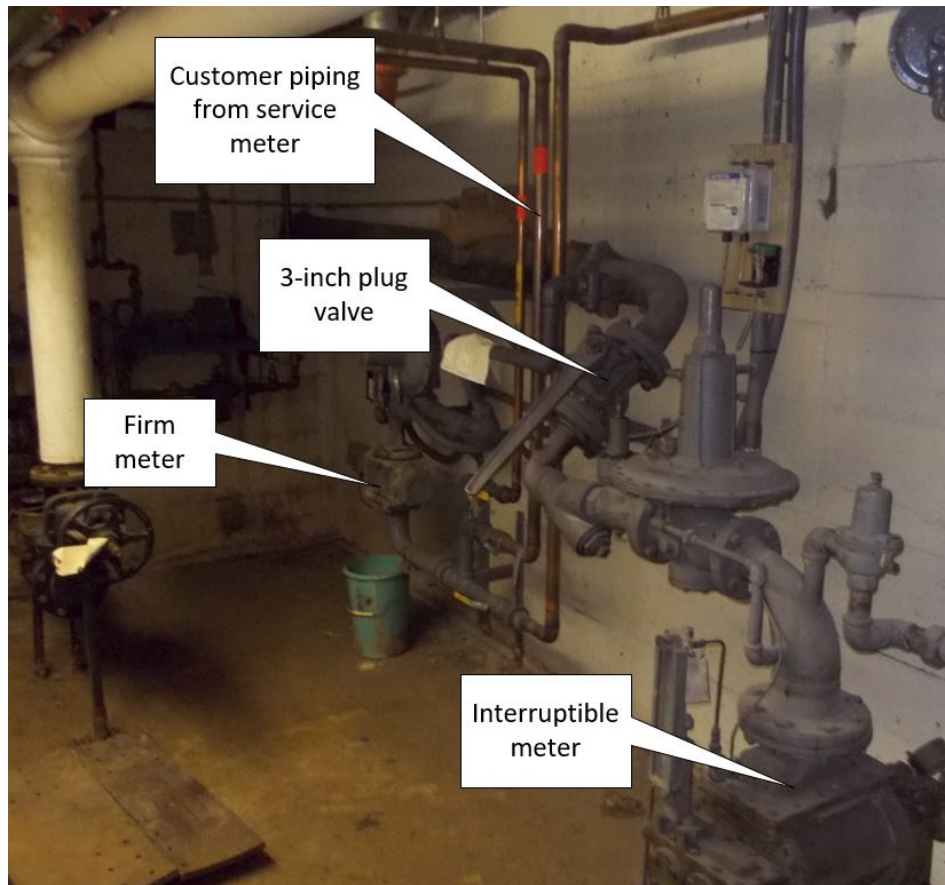
On the day of the accident, the two-person MMI pipefitting contractor crew was making modifications to piping upstream of the firm and interruptible meters, meaning the two-person crew was working on jurisdictional piping. Figure 3 is a photo taken before the accident showing the vault area of the center section of the building basement and describing the individual damaged piping elements involved in the accident. The photo depicts the location of the nonjurisdictional section of gas pipe and the jurisdictional piping that was being dismantled by the contractor work crew during the accident.

Figure 3. Photo taken before the accident of vault area of the center section of the building basement. (Source: CPEMG.)
